SR1521z REPAIR MANUAL

These instructions are intended to help restore any ailing SR1521z Active Loudspeaker back to factory working conditions. They show how to remove and replace the drivers and the amplifier assembly.

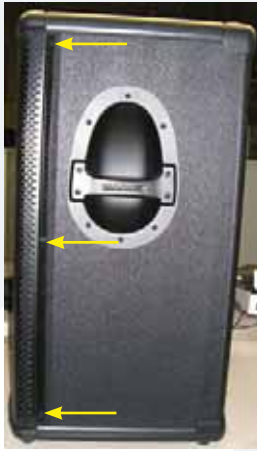
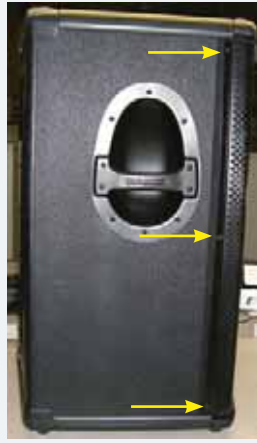
- 1** Three screws need to be removed from each side of the grill using the phillips head screwdriver (six screws in all).

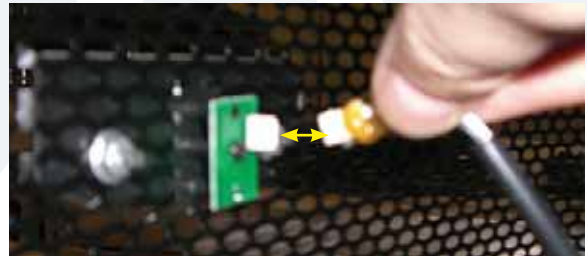
- 4** Carefully remove the cable attached to the led PCB assembly.

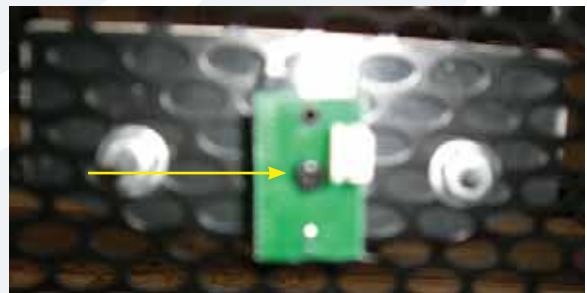
- 5** Use phillips head screwdriver to remove one screw from center of led PCB assembly.

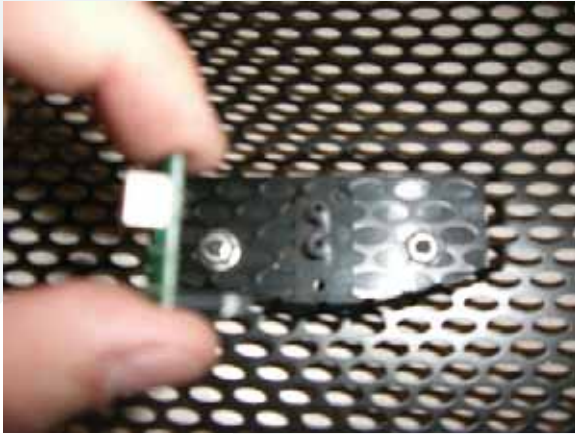
- 6** Carefully remove the led PCB assembly from the back side of the grill. A flat head screwdriver may aid in removal of the led PCB assembly if it is sticking.
- 7** The hard part is done, the rest is easy! Place the new led PCB assembly (part #0007334) where the old one was. Follow the same steps as above, but backwards 6 to 1. Power up the SR1521z and the led should light up. Congratulations, you just replaced an led PCB assembly...now go play some shows!

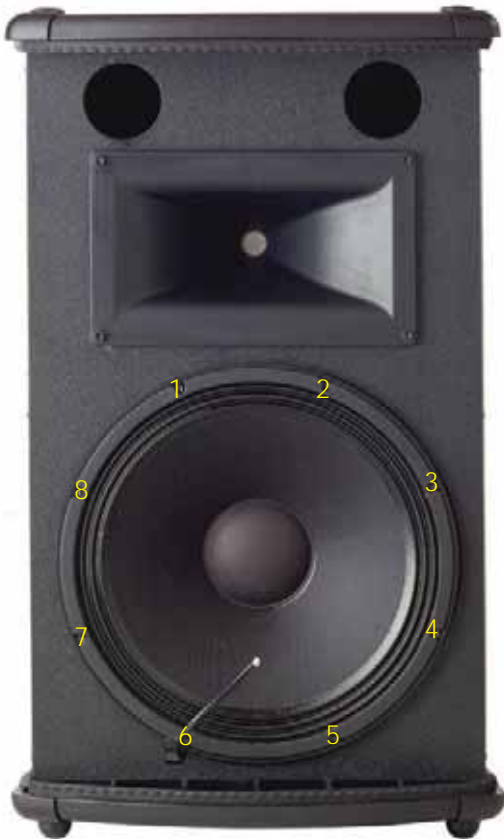
- 2 Eight screws need to be removed from the woofer using the 4mm allen wrench.

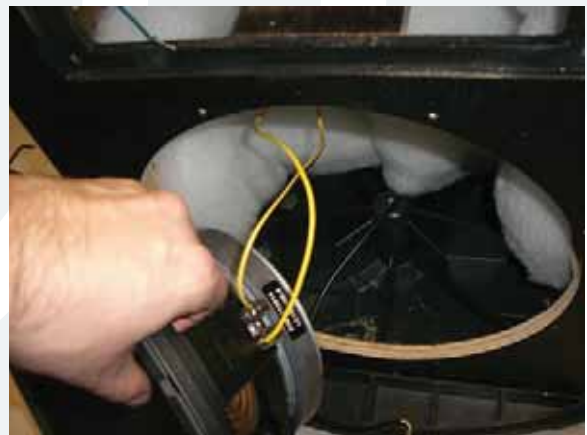
- 4 Carefully begin to remove the woofer. This woofer has a tendency to want to "pop out," so please be sure to hold the woofer in place with your free hand while removing the screws with the other hand.

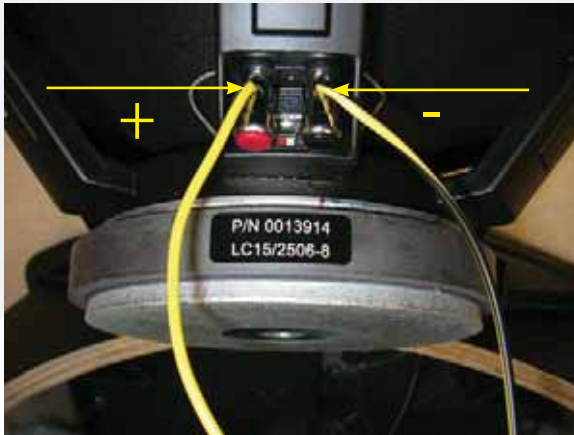
- 5** The positive (solid yellow) and negative (yellow and black) cables are still attached to the woofer terminals.

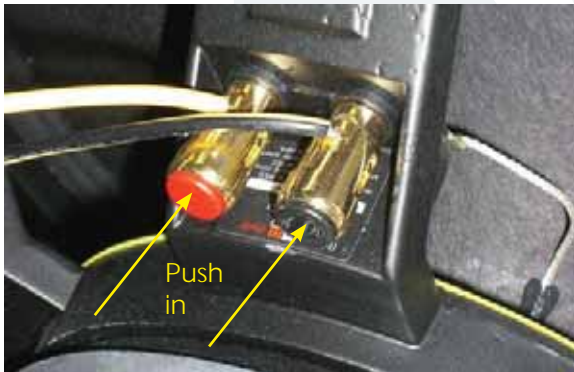
- 6** Remove the cables from their terminals simply by pushing down on the terminal and pulling out the cable.

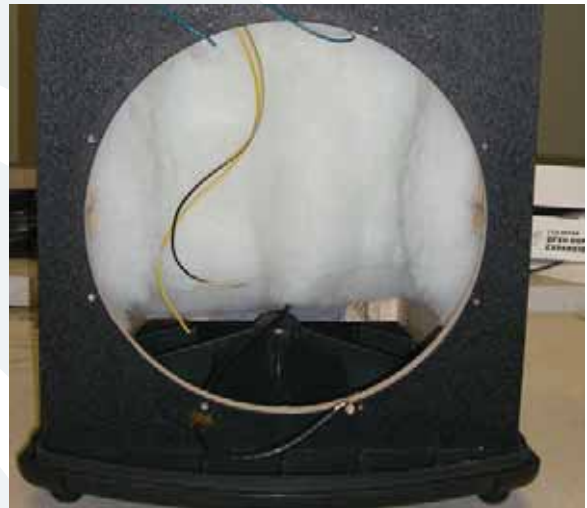
- 7** This is what it looks like with the grill and woofer removed. Place the new woofer (part #0013914) where the old one was. Follow the same steps as above, but backwards 6 to 1, making sure to keep the led PCB assembly cable in front of the woofer. Power up the SR1521z and the new woofer should now be pumping out glorious lows. Awesome, you just replaced a 15" woofer!

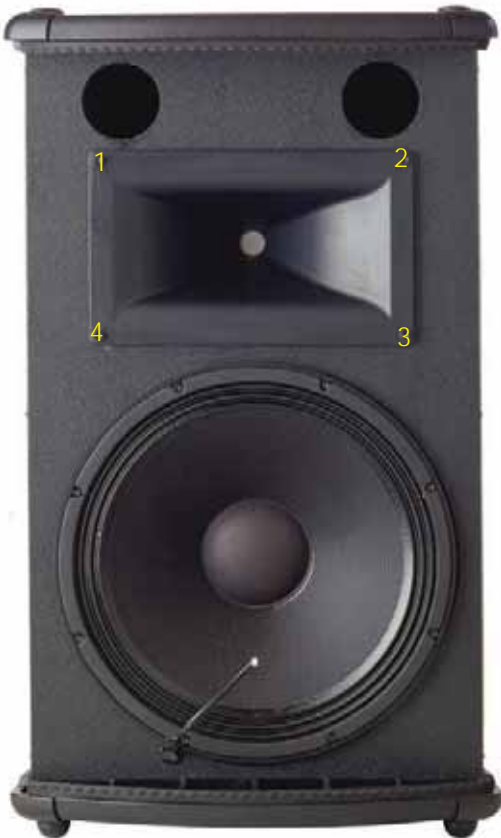
- 2 Four screws need to be removed from the horn using the 5mm allen wrench.

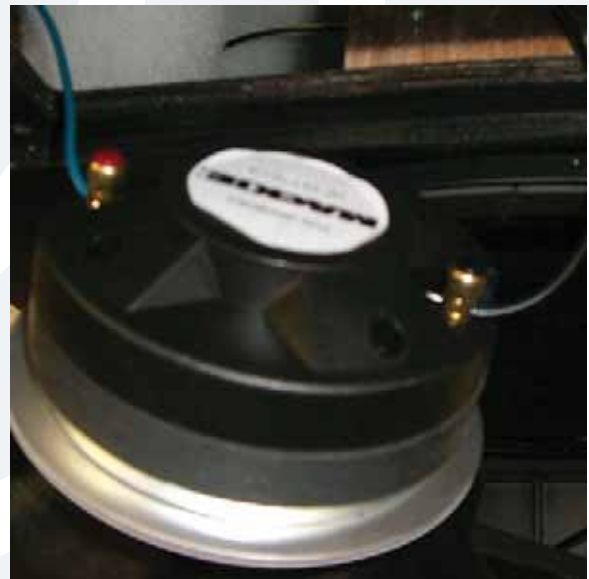
- 4 Carefully begin to remove the entire horn assembly (with the high frequency driver still attached).

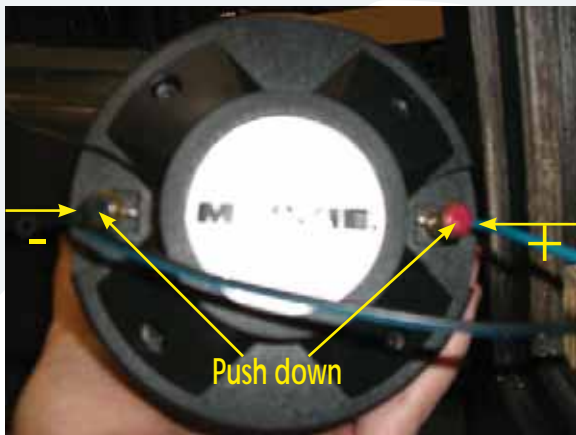
- 5** The positive (solid blue) and negative (blue and black) cables are still attached to the high frequency driver terminals. Remove the cables from their terminals simply by pushing down on the terminal and pulling out the cable.

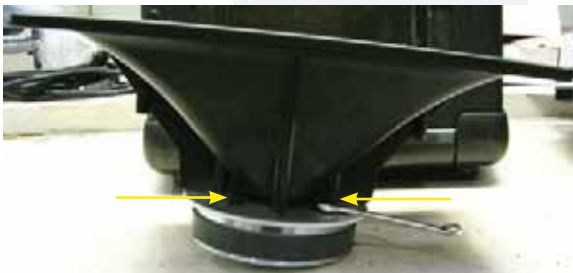
- 6** Four nuts and eight washers may be removed from the driver using the 8mm open end wrench. Turn counter-clockwise to loosen and remove, clockwise to tighten. The other pair is in the same place on the other side of the horn assembly.

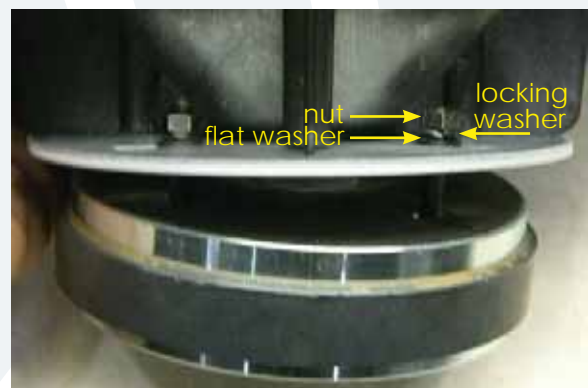
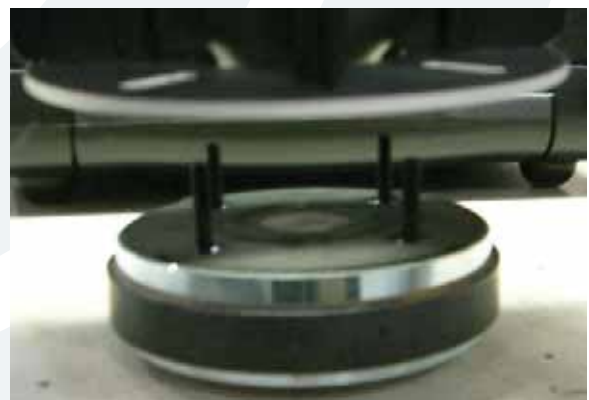
- 8** Lift the horn up as the nuts are loosened. It cannot be removed otherwise. Notice that the flat washer is on the bottom, followed by the locking washer, and finally the nut.

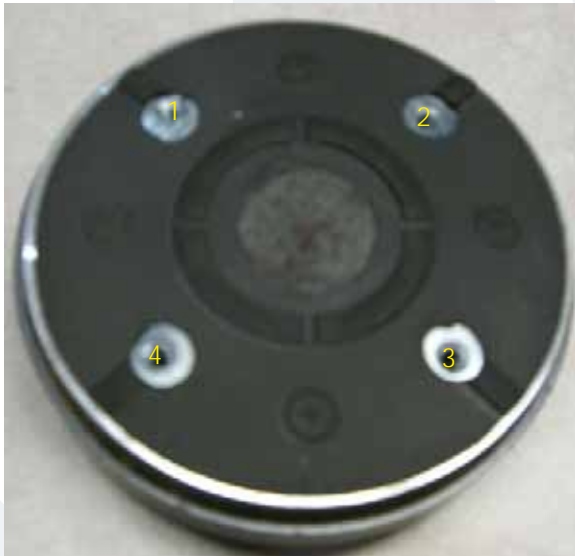
- 9** This is what the high frequency driver looks like removed from the horn assembly. Four headless screws need to be removed from the driver. Pliers could help if the screws are too tight. Turn counter-clockwise to loosen and remove, clockwise to tighten.

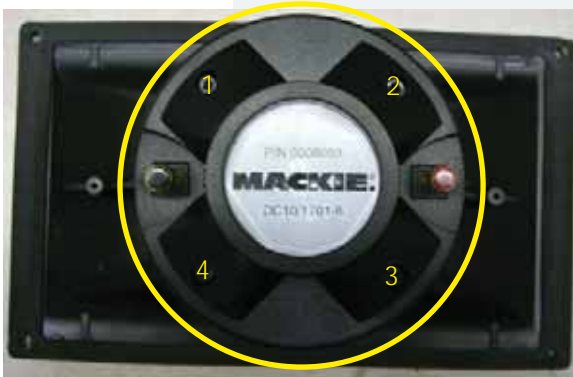
3 The horn is shown above with the high frequency driver circled. Four screws need to be removed from the driver using the 3mm allen wrench.

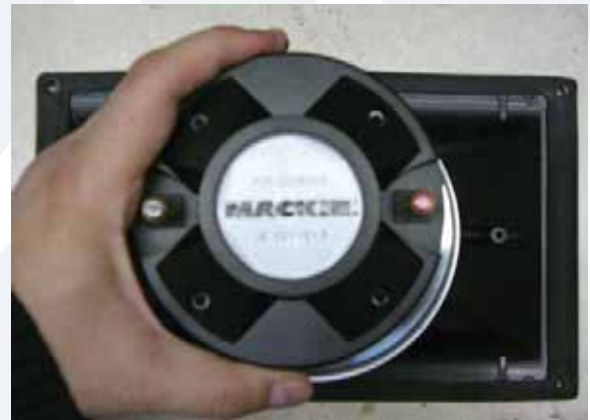
5 The diaphragm and plate adapter are easily removed from the horn assembly.

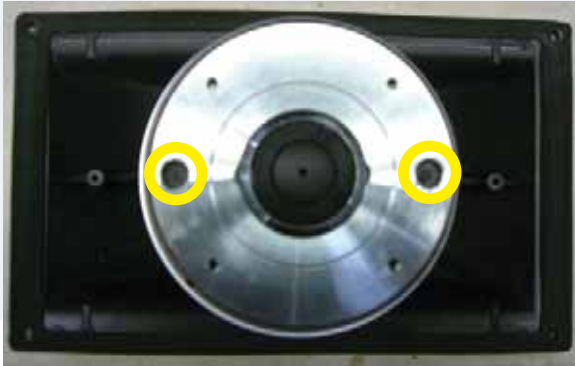
6 This is what the horn assembly looks like with the diaphragm and plate adapter removed. When replacing the new diaphragm, be sure to line up the holes correctly. Notice where the terminal connections fit (circled above).

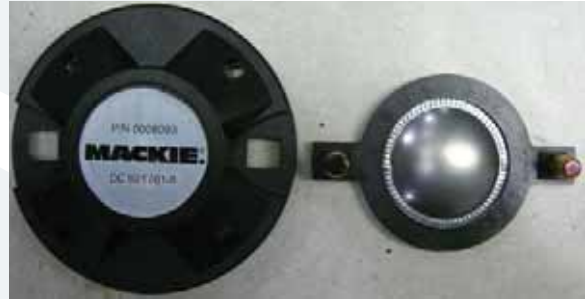
8 This is what the plate adapter (left) and diaphragm (right) both look like. Place the new diaphragm (part # coming soon) where the old one was. Follow the same steps as above, but backwards 7 to 1. Power up the SR1521z and the new diaphragm should now be pumping out those highs again. Sweet, you just replaced a diaphragm!

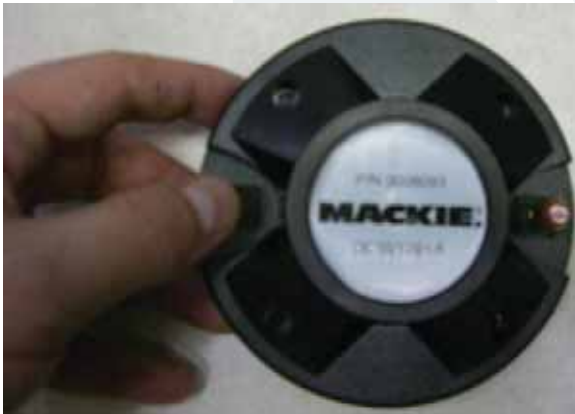
7 The diaphragm is separated from the plate adapter simply by pushing down on terminals.

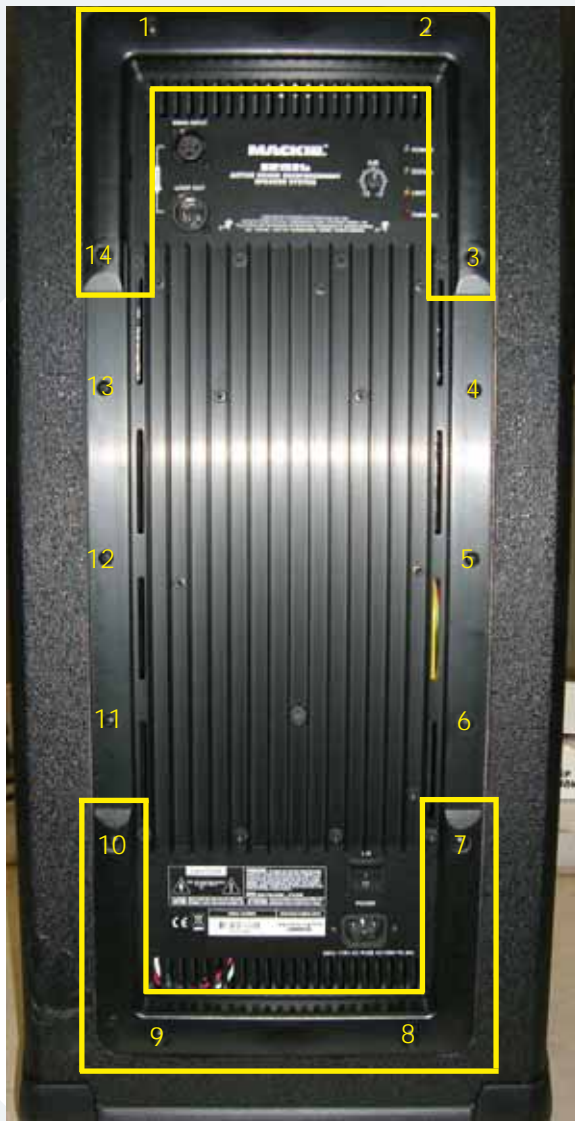
- 1** Fourteen screws need to be removed from the amplifier assembly using the phillips head screwdriver. The amplifier assembly is capped by two cover plates (part #33901380) outlined above.

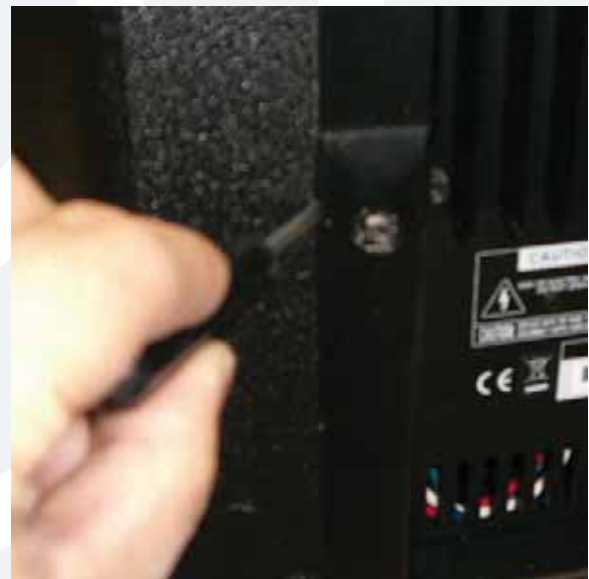
- 3** The covers may be worked loose by wedging a flat head screwdriver in between the cabinet and the cover, as well as the amp assembly and cover. Make sure to get around the entire cover plate in order to liberate them.

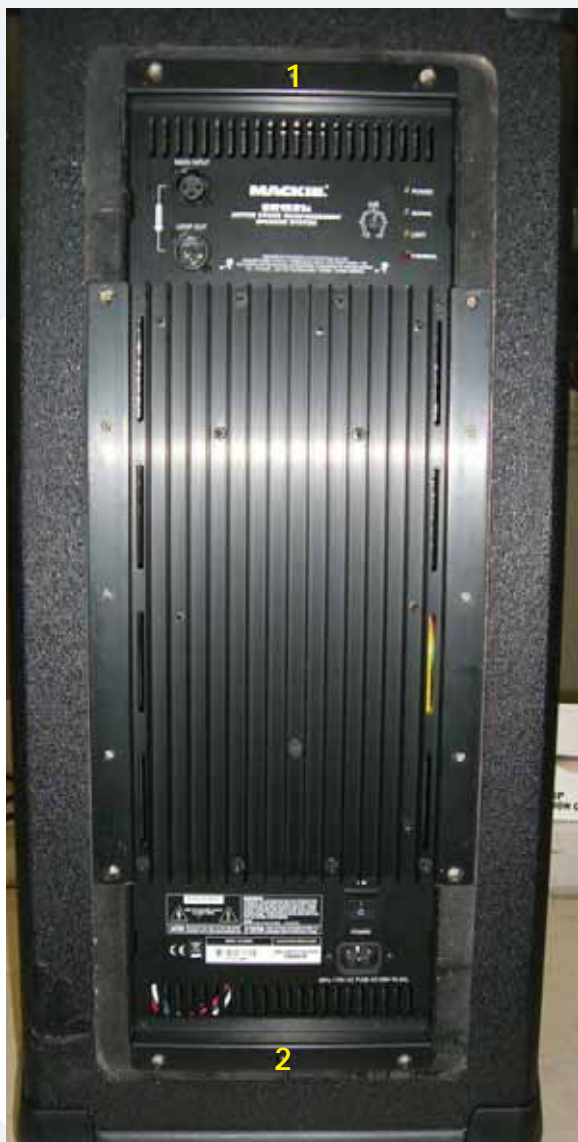
- 4 Once the two cover plates are removed, two more screws need to be taken out in order to separate the amplifier assembly from the cabinet. Keep the two screws in a safe place.

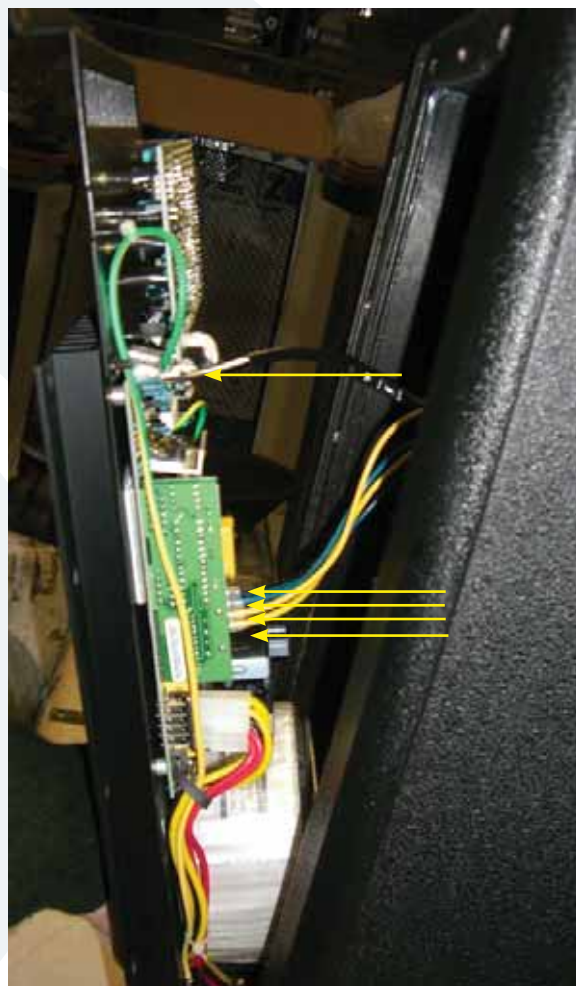
- 5 The amplifier assembly is now ready to be separated from the cabinet. Do not completely take the amplifier assembly off yet, as five cables need to be removed first (as shown above).

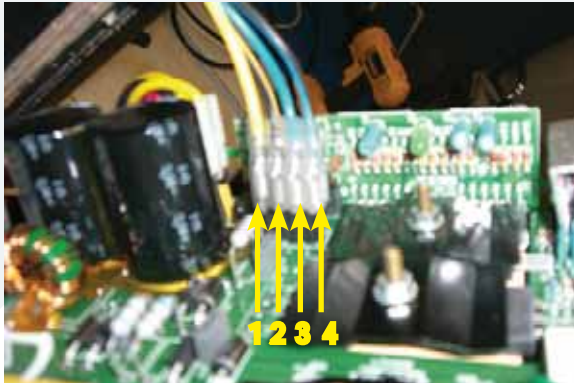
- 6** Five cables need to be removed from the amplifier assembly: (1) solid yellow, (2) yellow and black, (3) solid blue, and (4) blue and black. The fifth cable (led PCB cable) is shown in step 7 below. Do not force cable removal or connection, although needle-nose pliers may aid in loosening the crimped cables.

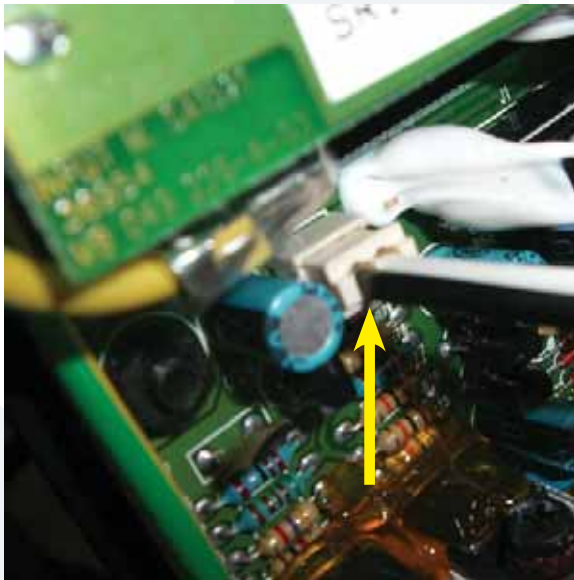
- 7** The led PCB cable is shown above. The black wire of the cable is closest to the edge of the amplifier assembly. The cable only fits in one way.

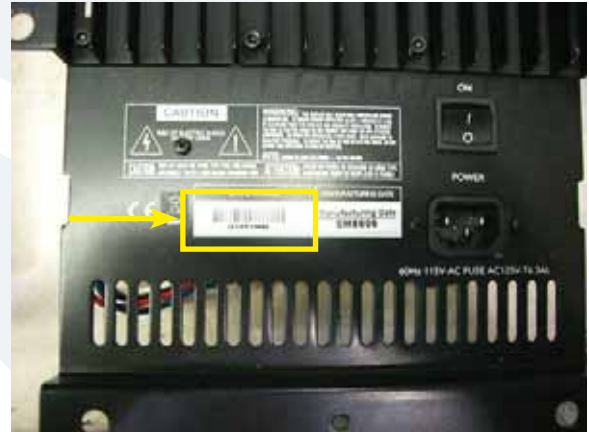
- 8** Place the new amplifier assembly (part #0014137-00) where the old one was. Follow the same steps as above, but backwards 7 to 1. Remove the serial number from the faulty amplifier assembly (as shown in picture above) and place on the new amplifier assembly. Power up the SR1521z and relish in the fact that you just replaced an amplifier assembly. Hats off to you for a job well done!
